BUILDING AND BRIDGE POUNDING DAMAGE OBSERVED IN THE 2011 CHRISTCHURCH EARTHQUAKE

SUMMARY

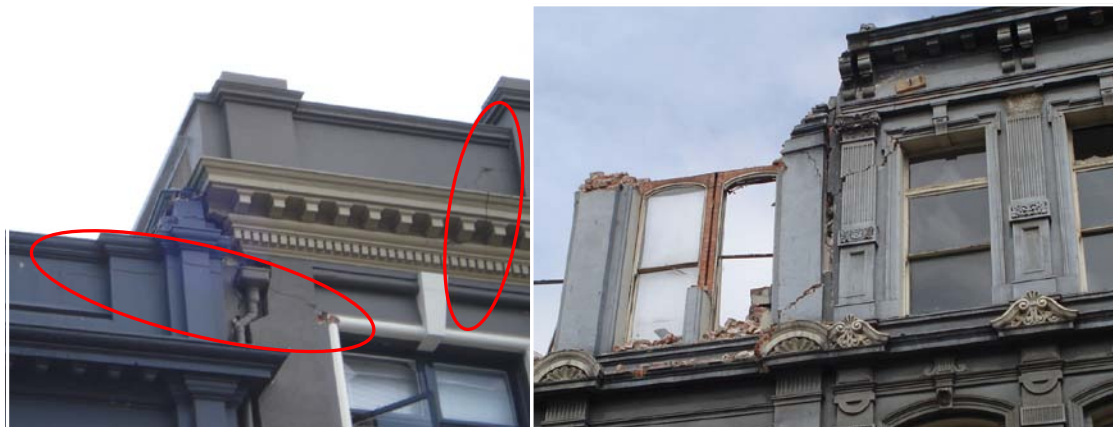
Figure 1: Examples of URM pounding damage. Left: minor damage. Right: major damage partially caused by pounding

Pounding damage to URM buildings (for example, Figure 1) occurred sufficiently frequently to enable identification of common damage patterns (Figure 2). Masonry cracking typically extended from the topmost point of contact between two buildings to the nearest window arch or lintel in each building. Cracking frequently extended further from the window opening through to the top of the building's parapet, although this parapet damage was not usually attributed to pounding. Multistorey buildings occasionally also presented damage at lower floors, although this damage was observed to be progressively less severe as the distance from the topmost point of contact increased. Cracking was also observed to concentrate in stiff lateral elements, such as wall sections with wide spacings between window penetrations (Figure 2a). Occasionally, local crushing of masonry units was observed at the point where two floors collided. When buildings of differing height collided, the floor immediately above the topmost point of contact also frequently suffered notable cracking. Figure 2b presents an idealised load path diagram, which also reflects the typically observed masonry damage distribution. In reality the damage 'struts' were not oriented at 45 degrees. This angle was instead governed by the building's wall penetrations.

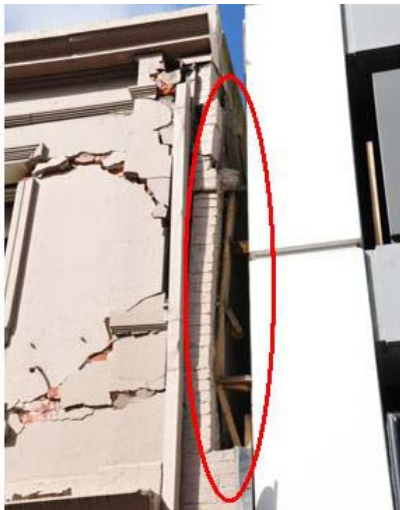
Modern buildings generally suffered less pounding damage. This is attributed to the greater building separations adopted in newer buildings and the presence of weaker adjacent buildings (for example, if a concrete reinforced frame building collided with a URM building, damage is more likely to occur first in the URM building due to its weak, brittle properties). The primary source of pounding damage in modern buildings with separation was instead observed where building separations were infilled with cosmetic flashings (Figure 3). While flashings are intended to cover the gap between adjacent buildings, the detailing of some flashings created stiff and strong elements, which transferred significant force between the two buildings. In some instances the flashings caused failure of adjacent building elements, while in other instances the entire flashing detached from both buildings. Flashing detachment can cause a sizable amount of falling debris when the buildings have multiple storeys. Furthermore, this form of damage can be simply avoided by designing flashings to compress/crush and ensuring they are adequately anchored to one building only. Five instances of significant damage resulting from force transfer through building flashings were observed within the CBD.

Figure 3: Building damage caused by framed flashing

- Modern buildings were primarily endangered by pounding when flashings between buildings were constructed with stiff and strong materials that allowed force transfer across building separations. This hazard can be mitigated by using compressible flashings attached to one building (but not both).

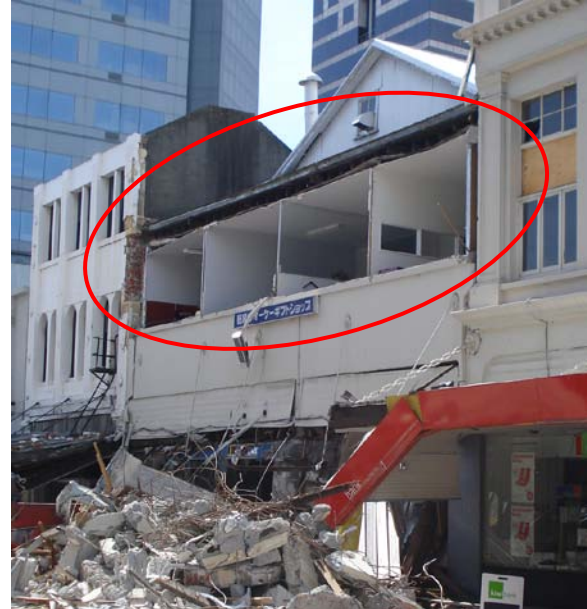
Three instances of buildings apparently being crushed from either side by adjacent buildings were also observed (Figure 4). This was evidenced by façade collapse and localised crushing damage at the points of contact with adjacent

buildings. It is noted that some engineers have expressed some doubt to the first author that the adjacent buildings contributed to this failure. However, an alternative explanation for the observed damage at the contact points has thus far not been presented. If pounding did contribute to these collapses, it is a particularly dangerous consequence for any pedestrians in the vicinity when an earthquake occurs, in addition to potentially compromising the building's overall stability. The illustrated example's façade was constructed of reinforced concrete, which typically performed very well elsewhere in the CBD. This further highlights the potential danger of this type of damage.

Figure 4: Facade loss attributed to building crushing

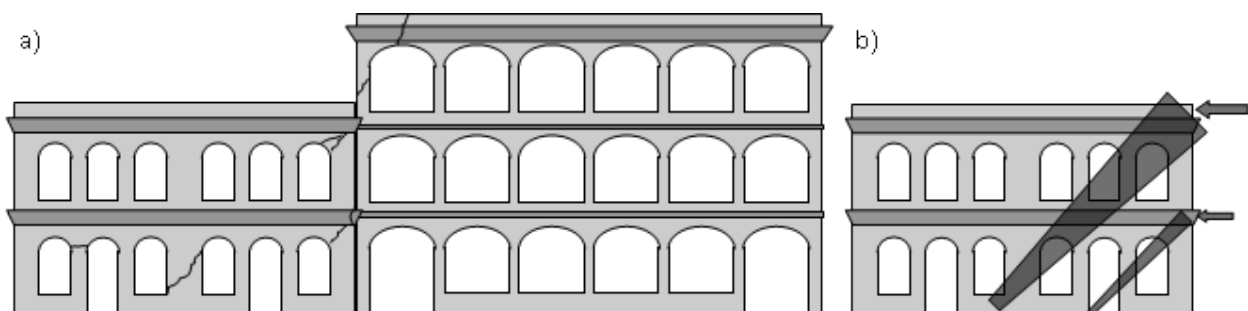
Figure 2: Damage to URM buildings. a) Typical pounding damage. b) Idealized masonry strut damage. Arrows denote floor collision points of the adjacent building. Width of the shaded zone indicates approximate severity of damage. Figure reproduced from [4].

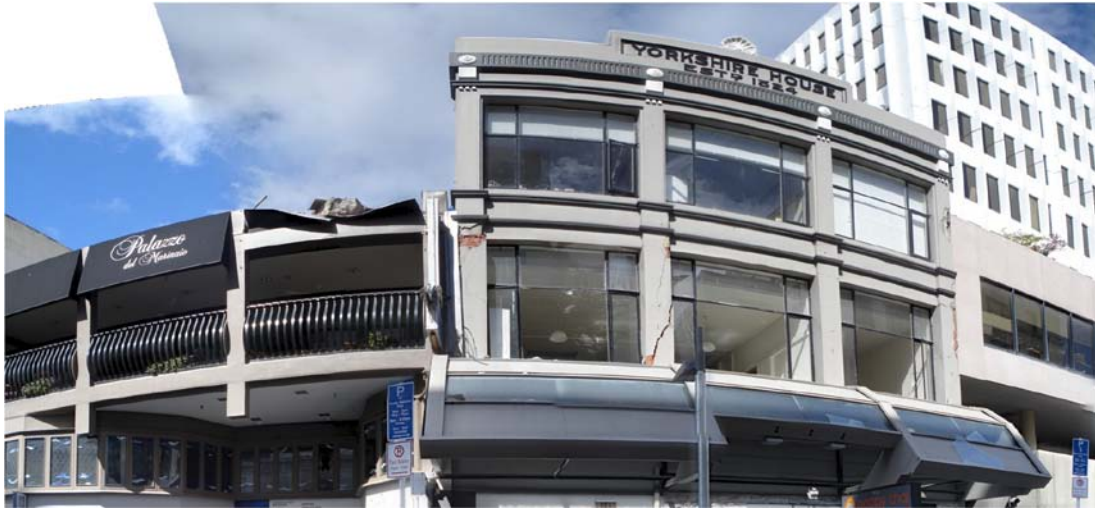
Figure 5: Pounding damage caused by buildings with greatly differing heights. Note image is distorted due to panoramic photography

As was also observed in the Darfield earthquake, very little pounding damage was observed between buildings of greatly differing overall heights. This is again primarily attributed to the greater separations that generally surround taller buildings. However, Figure 5 presents one building configuration where extensive pounding damage did occur. Pounding between the central building and the taller rightmost building also occurred in the Darfield earthquake. The damage in the Darfield earthquake was minor, although it was noted that this damage occurred in the vertical elements of the primary gravity structure [3].

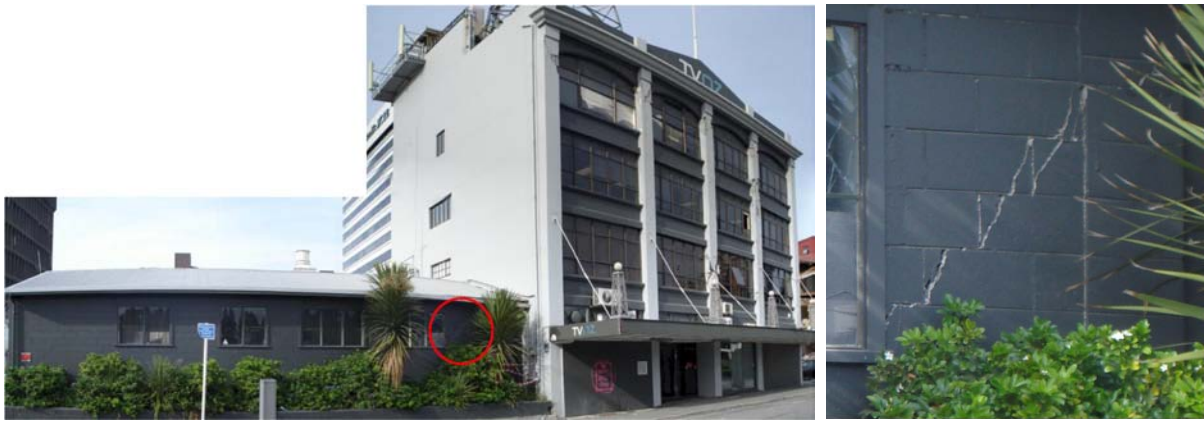
Figure 7: Pounding between 1 storey and 4 storey buildings. Damage to four storey building not attributed to pounding

The range of buildings affected by pounding sometimes extended to buildings where pounding would not normally be anticipated. One single storey building was observed to suffer substantial pounding damage as a result of contact with a neighbouring four storey building (Figure 7). The neighbouring four storey building was substantially damaged during the Christchurch earthquake, however this damage is not attributed to pounding. As a result of this damage, the lateral stiffness of the neighbouring building reduced, causing greater building deflection. It is considered that this effect has increased building damage, although its significance is unknown. Approximately 10 mm building separation was observed between these buildings.

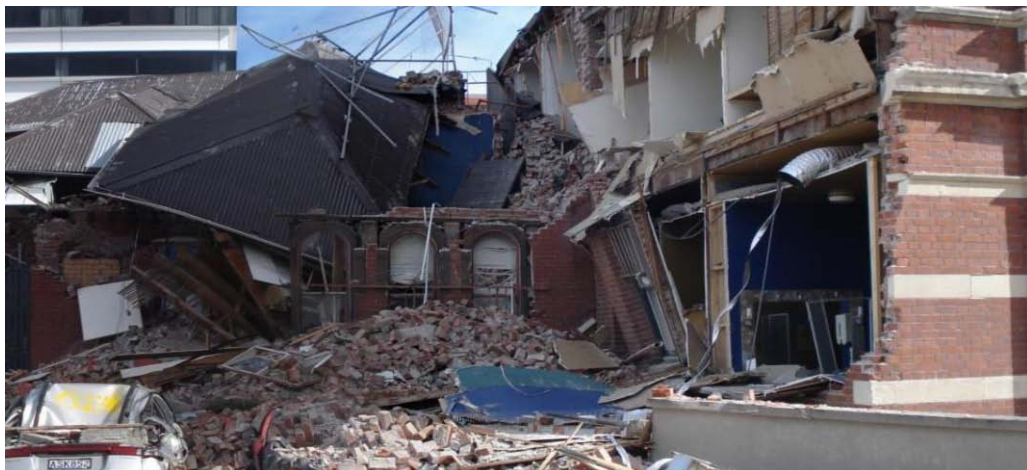
Two building collapses within the CBD are partially attributed to pounding. Both these cases involve URM buildings that were constructed circa 1900. Figure 8 illustrates the damage caused to a two storey URM building that sustained pounding during the Christchurch earthquake (shown on the left). Significant damage has also been sustained by the adjacent right building. These buildings were externally surveyed after the Darfield earthquake and were found to be separated by approximately 50 mm at ground level, but were in contact at roof level. It was concluded that the two storey building had begun to lean, although whether this was due to the Darfield earthquake could not be determined. As these buildings were in contact, pounding undoubtedly occurred during the Christchurch earthquake. However, the primary cause of collapse is attributed to the URM construction. Whether pounding appreciably contributed to this collapse is very difficult to determine, due to the level of destruction that has occurred.

Figure 8: Two storey building collapse involving pounding. Primary cause of collapse is attributed to URM construction

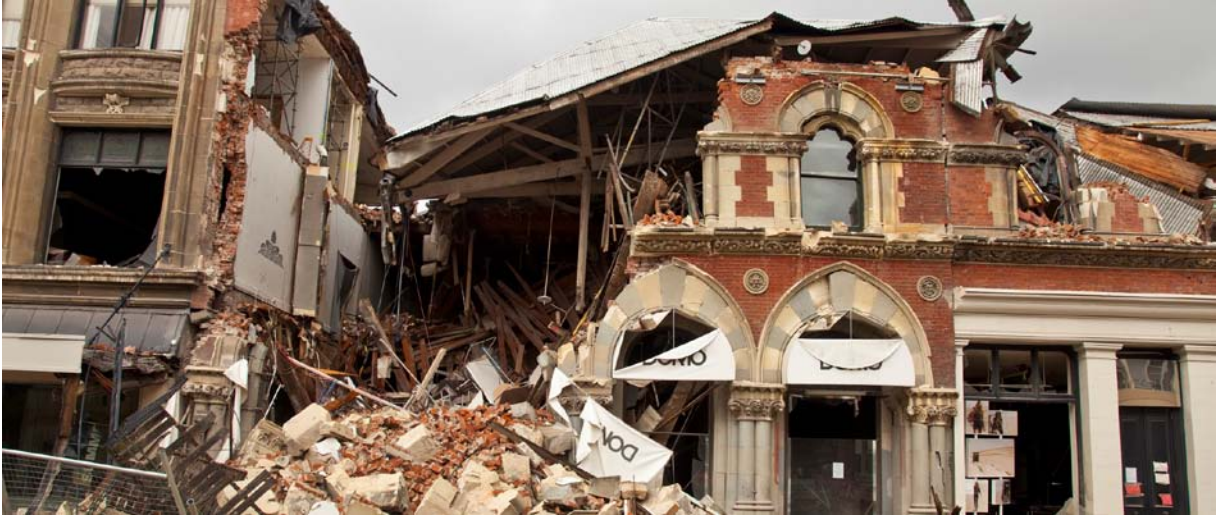
Figure 10: Building collapse involving building pounding. Primary cause of collapse is attributed to URM construction.
Photo courtesy of Colin Monteath, Hedgehog House.

The damage shown in Figure 10 indicates that the central and leftmost buildings were likely to be constructed with a shared party wall. This can be observed where wall sections remain standing at the building interface. At the second level, a 100 mm thick brick wall appears to have supported both buildings. This evidence is also supported by the interior finishings that can be observed on the 'exterior' of this wall. Nevertheless, localised damage consistent with pounding is present between the central and rightmost buildings. Once again it is difficult to discern the level of influence pounding has had on the presented collapse. The primary cause of collapse is attributed to the URM construction. However, it is credible that the severity of this damage would have been greatly reduced if adjacent buildings had not been present.

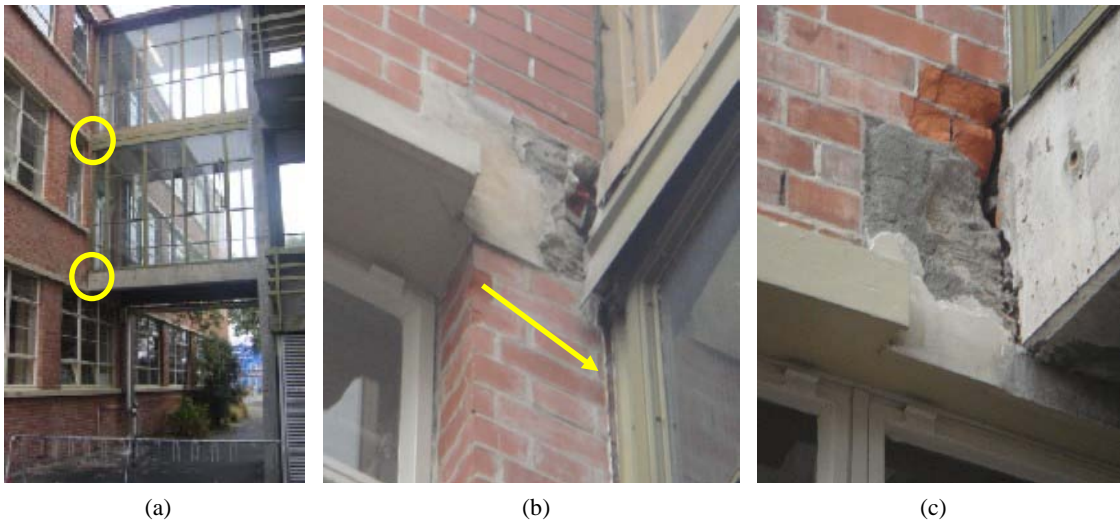
Figure 11: Pounding damage to buildings at the Christchurch Polytechnic Institute of Technology. (a) Adjacent buildings with pedestrian bridges, (b) upper and (c) lower pounding locations.

Pounding between adjacent buildings can be avoided if a sufficient gap exists. In some cases, however, although the adjacent buildings are well separated, pounding can still take place. This is the case when the buildings are linked by pedestrian bridges as the buildings at the Christchurch Polytechnic Institute of Technology along the Madras Street in Figure 11(a) show. The upper and lower pounding locations are indicated by the circles. The damage due pounding of the upper floor of the pedestrian bridge is displayed in Figure 11(b). The residual opening relative movement can also be clearly seen indicated by the arrow. Figure 11(c) shows the damage to the unreinforced masonry wall due to pounding of the lower RC floor of the pedestrian bridge. In the case considered both adjacent buildings have different fundamental periods owing to their dissimilar building configuration, and thus different oscillation pattern are to be expected. Previous studies on pounding responses between buildings linked by pedestrian bridges in near-source earthquakes have shown that neglecting of soil-foundation-structure interaction can underestimate pounding potential and also the induced vibrations in the buildings [6].

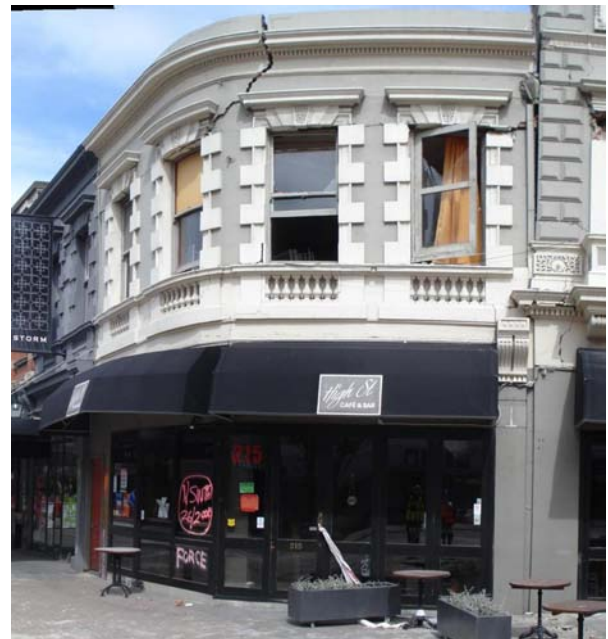
5. **Building subject to torsional actions arising from pounding.** Torsional pounding interaction was found to be particularly difficult to identify from external inspection. Only one possible case of torsional pounding interaction was observed in the CBD (Figure 14).

Figure 12 Possible torsional building pounding due to irregular plan layout

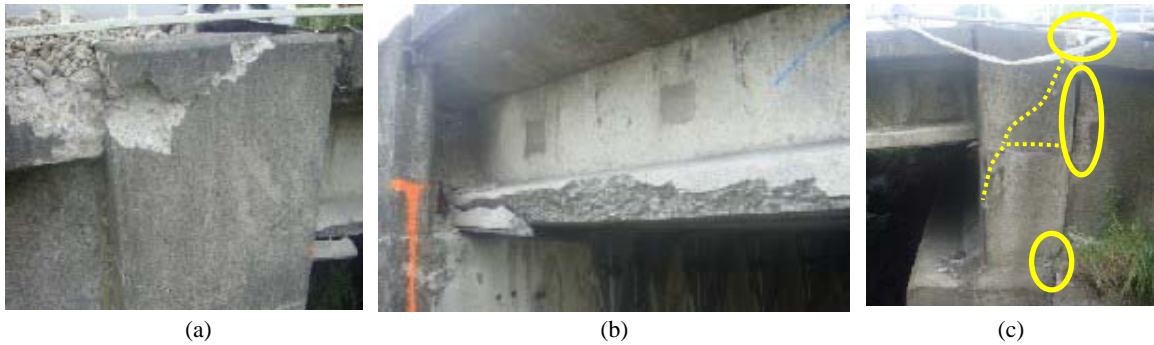
Figure 13: Fitzgerald Avenue Bridge. Pounding damage (a) at the abutment, (b) to the immediate adjacent girder and (c) to the other abutment.

Although the Christchurch earthquake did not cause spectacular damage to bridge structures due to their relative movement, i.e. bridge collapses due to pounding and unseating of the bridge deck such as observed in the 1995 Kobe earthquake in Japan [9], the 1999 Chi-Chi earthquake in Taiwan [10] or the 2010 Maule earthquake in Chile [11], the very short but strong pulses still caused pounding damage to a number of bridge structures in Christchurch and surroundings. Figure 13(a) shows the pounding damage to the abutment of the Fitzgerald Avenue Bridge. The damage to the immediate adjacent girder can be seen in Figure 13(b). The pounding caused a spall of the edge of the girder. Damage to the other abutment in Figure 13(c) occurred even along the entire height of the abutment wall as indicated by the circles. The cracks of the wall are indicated by the dotted lines. It should be noted that lateral spreading of the ground surface due to soil liquefaction occurred in the surroundings. This spatial variation of the ground movements might have amplified the relative movement between the two bridge structures and contributed to the poundings.

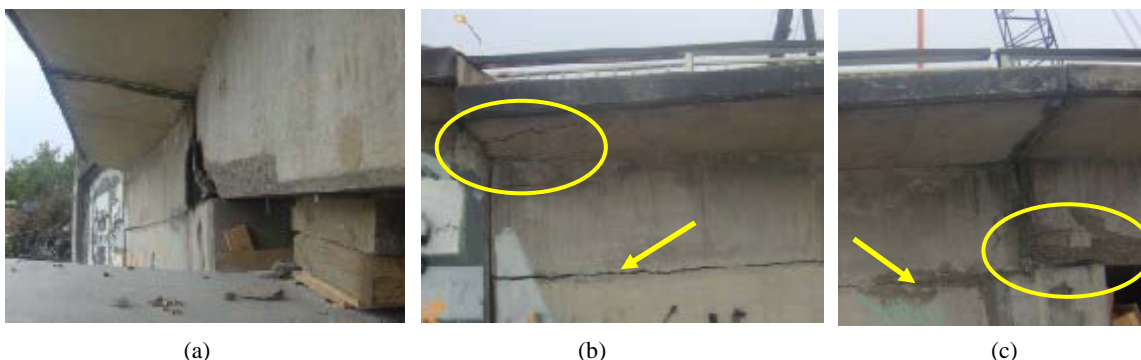
In Figure 14 the significant damage to the Ferrymead Bridge can be observed. The bridge is very valuable since each day approximately 30,000 vehicles were using the bridge that links Christchurch and Lyttelton. Severe soil liquefaction has been observed in the area, and thus behaviour similar to the Fitzgerald Avenue Bridge was expected. Figure 14(a) shows pounding induced spalling at the edge of the girder of the Ferrymead Bridge, which is similar to that observed at Fitzgerald Avenue Bridge (Figure 13(a)). The effect of the unequal soil settlement might also have amplified the closing relative movement as one can observe in Figure 14(b). The damage due to pounding to the upper deck is indicated by the circle. The closing relative movement caused a large horizontal crack at the interface between the upper deck and the supporting abutment as indicated by the arrow. Direct damage at the pounding location can be seen in Figure 14(c) (marked by a circle). The horizontal crack in the abutment due to the pounding is indicated by the arrow.

Figure 14: Ferrymead Bridge. Pounding damage (a) to girder, (b) at abutment and (c) at girder-abutment location.
